Baby Lock Unity (Model BLTY) Software Update Version 4.00

June 2019

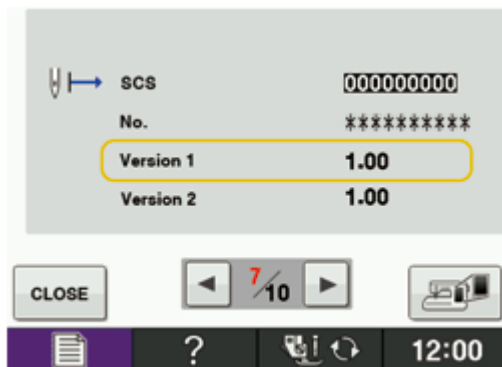
(Next page key) to display the software version.

5. If “**Version 1**” shown in the screen is already **4.00** or later, it is not necessary to update your machine with the software on this page.

If “**Version 1**” shown in the screen is lower than **4.00**, follow the procedure to update your machine.
